**REPORT#:** 23CA002

**REPORT DATE:** July 25, 2024

## Poultry Processing Production Worker Drowns in an Open Offal Wastewater Pit — California

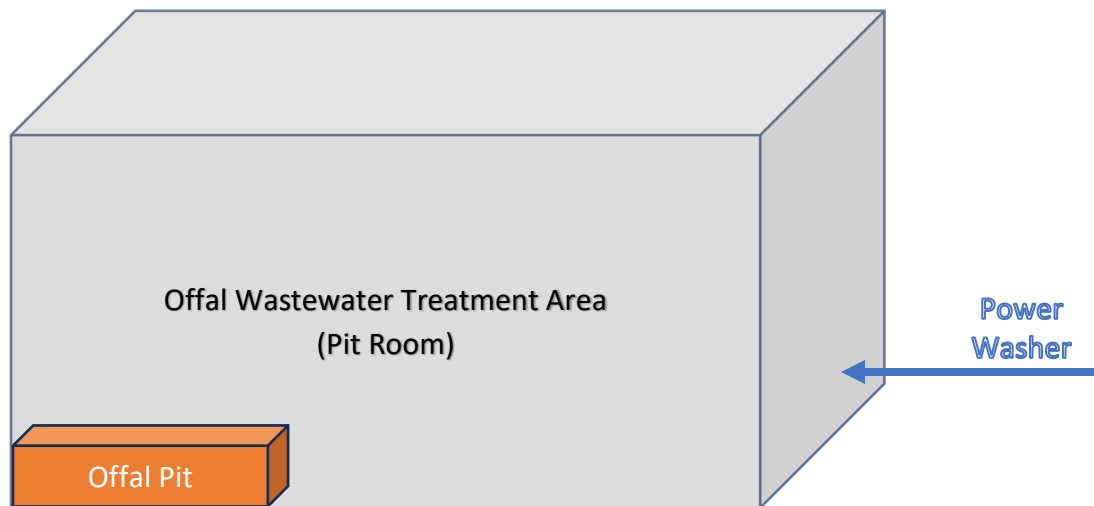
**Exhibit 1. Illustration of the incident scene (Courtesy of the CA/FACE program).**

The incident scene was an offal pit in the offal wastewater treatment area on the lower level of the facility (Exhibit 1). The pit dimensions were 14 ft wide x 8.6 ft long x 17 ft deep. On the day of the incident, the pumps were turned off and this caused an overflow. To remove the excess offal in the wastewater pit, a backhoe was

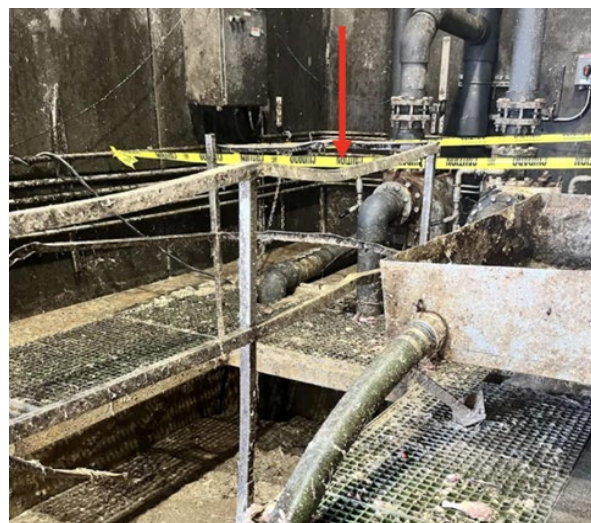
One week prior to the incident, the backhoe damaged the stainless steel guardrails surrounding the pit and they had not been repaired prior to the incident (Exhibit 2). There were no confined space warning signs on or around the pit. There were three newly installed trash pumps and one existing pump adjacent to the pit that was being used to process the offal wastewater.

**Exhibit 2. One of the damaged guardrails (red arrow) surrounding the offal pit. Photo courtesy of the employer.**

Discussion: At the time of the incident, photos showed that the guardrails protecting the open offal pit were damaged, and they did not completely enclose the pit. It was reported that the company's maintenance crew constructed the stainless steel guardrails and testing was not conducted to determine the applied live load limits. It is crucial that guardrails are designed, built, installed, tested, and maintained according to federal, state, and/or local regulations applicable to their jurisdiction. Cal/OSHA regulation is [§3209. Standard Guardrails](#) and federal OSHA requirement is [29 CFR 1910.29 Fall protection systems](#).

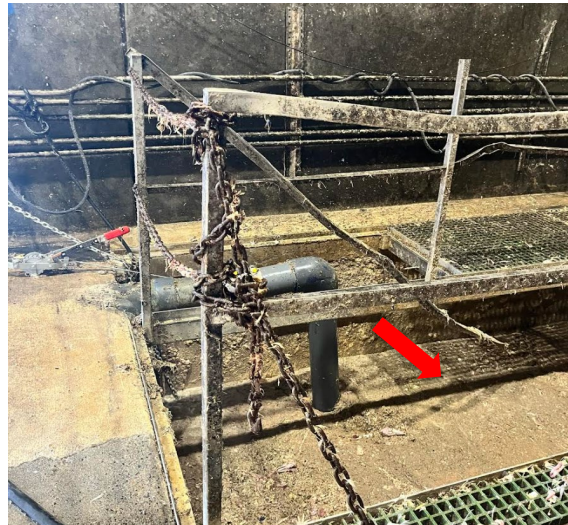
According to the Cal/OSHA investigation, police, and fire department reports, on the day of the incident there was a missing floor grating on the east side of the pit. Additionally, there were damaged guardrails on three sides of the pit (Exhibit 3). An employee stated that it was possible that the backhoe used to empty the pit weekly hit the guardrail and bent it.

**Exhibit 3. The offal wastewater pit on the day of the incident.  
Arrow indicates where victim likely fell in. Photo courtesy of the employer.**

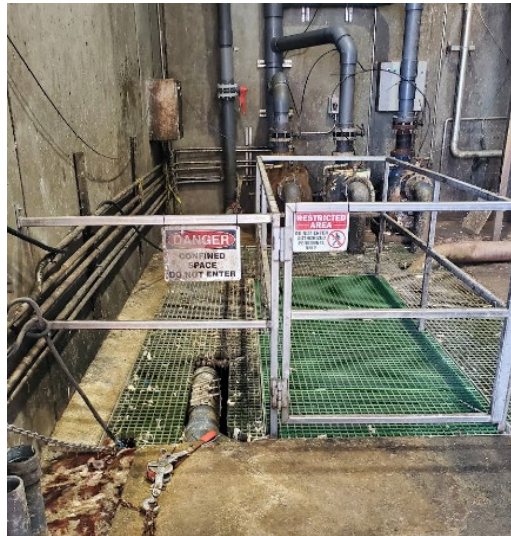
**Exhibit 4. The new guardrails and floor grates that were installed after the incident.**  
Photo courtesy of the CA/FACE program.

On the day of the incident, a grate had been removed. The photo below (Exhibit 4) was taken on the day of the CA/FACE investigator's visit, and a new guardrail system and floor covering/grate had already been installed around the offal pit. According to federal OSHA requirement 29 CFR 1910.28 Walking-Working Surfaces (b) (3) (v) (A) when a hole (i.e., the offal wastewater pit) is not in use, the employer must ensure the cover is closed or a removable guardrail system is provided on the exposed sides. If materials are passing through the hole or work is being done in the pit, one feasible alternative is to have a hinged floor cover, which helps ensure that the cover will be replaced when work is done. On the day of the incident, if the pit

had been guarded on all open sides and a hinged floor hole cover was used, it may have been less likely the victim would have fallen into the pit and died.
