REPORT#: 23CA003

REPORT DATE: July 25, 2024

Ironworker Working in a Trench Dies When He Is Crushed by an Adjacent Retaining Wall That Fell on Him — California

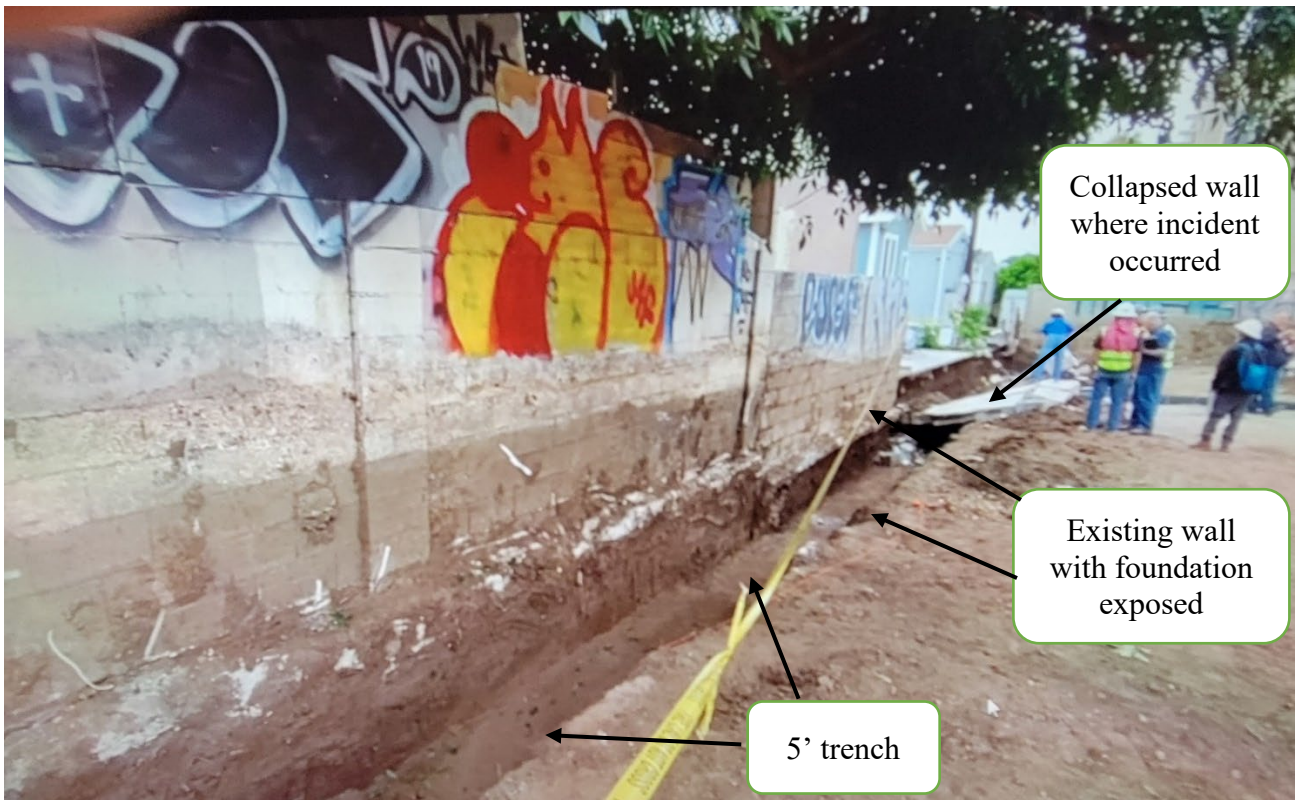
The incident scene was a vacant lot that was being prepared for the construction of a warehouse. A general contractor was building the warehouse, and the employer (subcontractor) was building a perimeter wall on the south side of the lot bordering a mobile home park. The fatality occurred in a five-foot deep, 150-foot-long trench (Exhibit 1) where the foundation for the new perimeter wall would be.

Exhibit 1. The incident scene depicting the trench in relation to the existing retaining wall. Photo courtesy of KTLA 5 News.

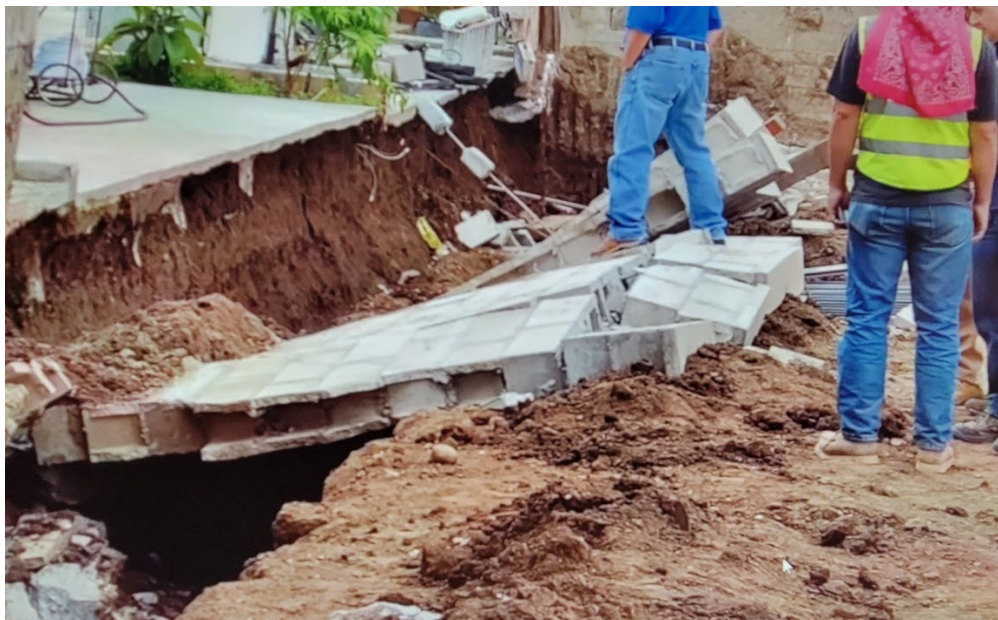
On the morning of the incident, the victim and three co-workers reported to the location to begin work. They entered the trench and began installing rebar for the new retaining wall. The workers dug below the level of the base or footing of the adjacent retaining wall. Shoring was not in place and no bracing or underpinning was used to ensure the stability of the existing wall. While they were working in the trench, the retaining wall suddenly collapsed. Two of the workers were able exit the trench unharmed. 911 was immediately called and the fire department and rescue squads arrived and attempted to rescue the two remaining trapped workers (Exhibit 2). One worker was removed successfully and transported to the hospital for treatment, but the victim was pinned underneath the retaining wall and died at the scene.

Exhibit 3. The collapsed portion of the wall. Photo courtesy of KTLA 5 News.

Recommendation #3. Ensure that bracing, shoring or underpinning are used to support adjacent walls that are potentially unstable.

In this incident, the excavation for the trench and installation of the rebar was performed without the use of a support system such as bracing, shoring or underpinning. If a support system had been implemented prior to entering the trench, the victim would not have been crushed by the adjacent wall.
