**REPORT#:** 23CA004

**REPORT DATE:** December 1, 2024

## A Tow Truck Operator Dies on a Highway When He Is Struck by a Car While Loading a Vehicle onto a Tow Truck — California

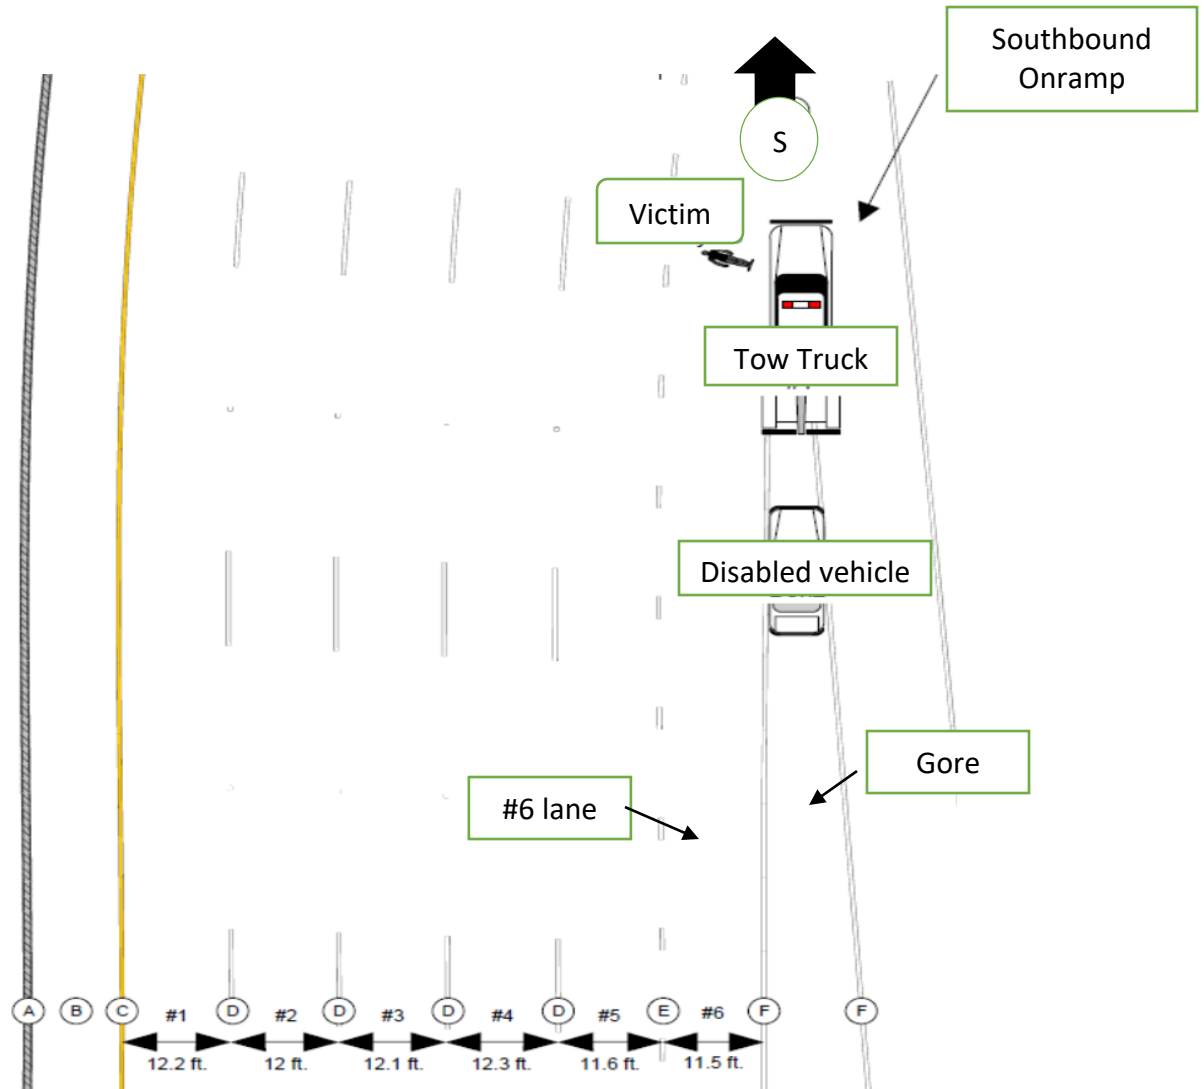
The incident scene was a six-lane southbound interstate highway located within a major city/county. The six asphalt lanes were each 12 feet wide and delineated by painted broken white lines. The incident occurred in the #6 lane adjacent to a triangular shaped gore<sup>1</sup> that was between the highway and a southbound onramp. The #6 lane merged just ahead of the incident scene with the southbound onramp

Exhibit 1. A diagram of the incident scene. Photo courtesy of the CHP.

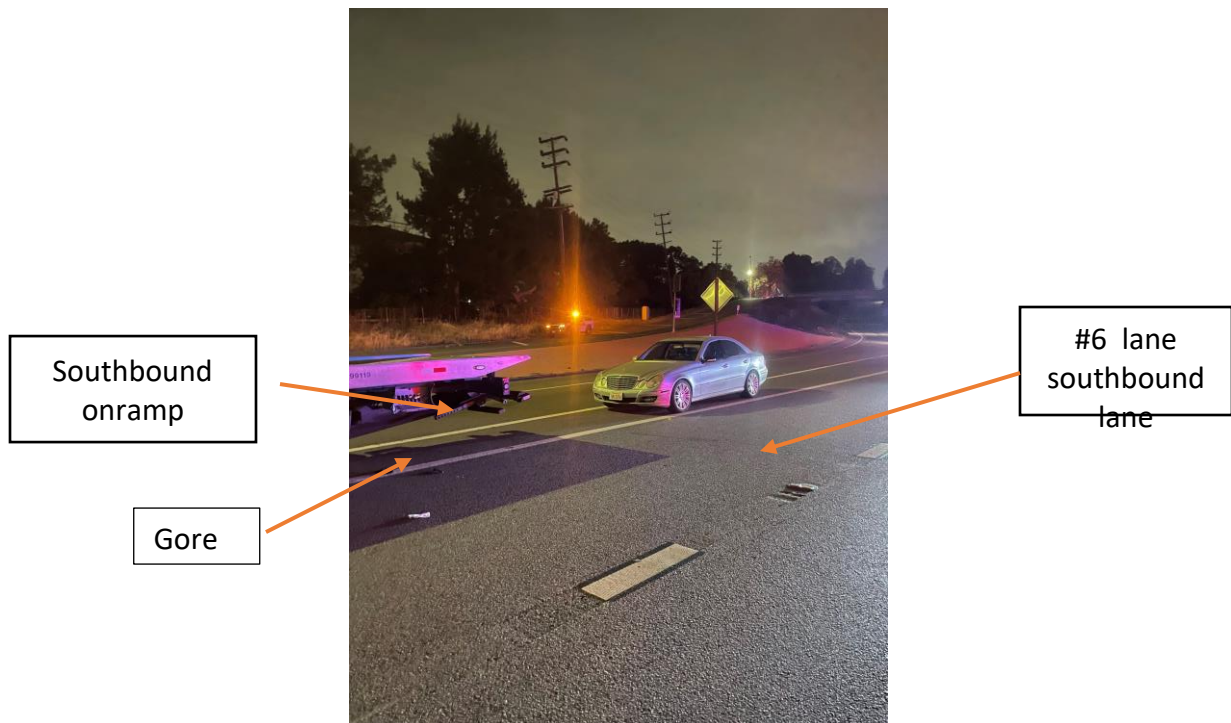
On the night of the incident, a vehicle was driving southbound in the #6 lane of the highway when it suddenly developed engine problems. The driver pulled her vehicle over and stopped on a gore in between the #6 lane and the highway southbound onramp (Exhibit 2). It is not known why the driver pulled onto the gore and not the shoulder of the road. The driver called for emergency roadside service and the company initially dispatched a roadside assistance pickup truck to the incident scene. After the co-worker in the pickup truck was unable to jump start the disabled vehicle, the victim was dispatched in a flatbed tow truck to the incident scene to load and remove the vehicle. The pickup truck moved to the shoulder of the highway adjacent to the onramp with the driver of the disabled vehicle.

Exhibit 2. The tow truck's position after backing in front of the disabled vehicle.  
Photo courtesy of the CHP.

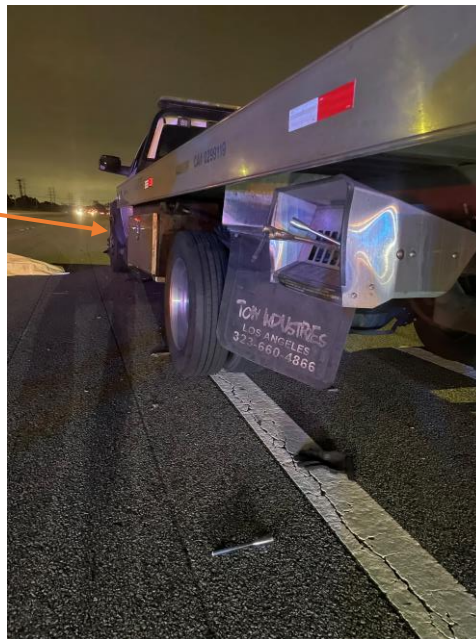
Tow truck  
control levers

The victim arrived on scene with flashing amber lights and pulled in front of the disabled vehicle in preparation for towing. Photos from the scene show that the flatbed truck was partially in the #6 southbound lane (Exhibit 3) and the southbound onramp (Exhibit 4) due to the relatively narrow triangular area of the gore.

Exhibit 3. The tow truck partially in the #6 lane with control levers in front of the back tire. Photo courtesy of the CHP.

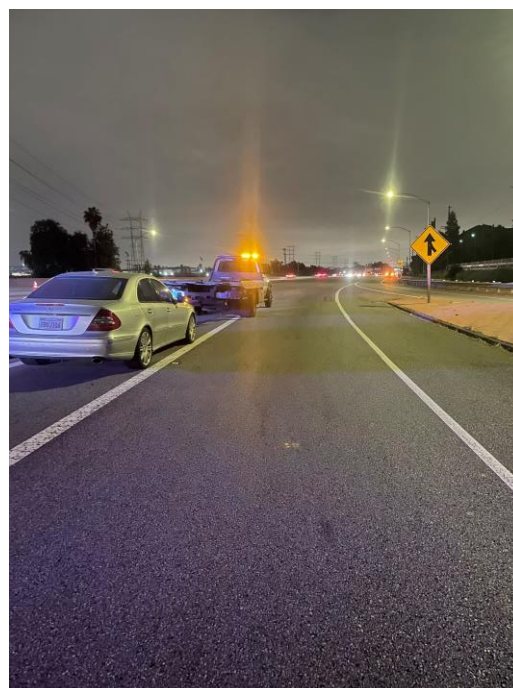
Exhibit 4. The tow truck partially in the southbound onramp. Photo courtesy of the CA/FACE program.
