**FATALITY ASSESSMENT AND CONTROL EVALUATION PROGRAM  
(CA/FACE)**

A farm laborer died after he was caught in the  
rotating feed roller of a brush shredder  
Case Report: 21CA002

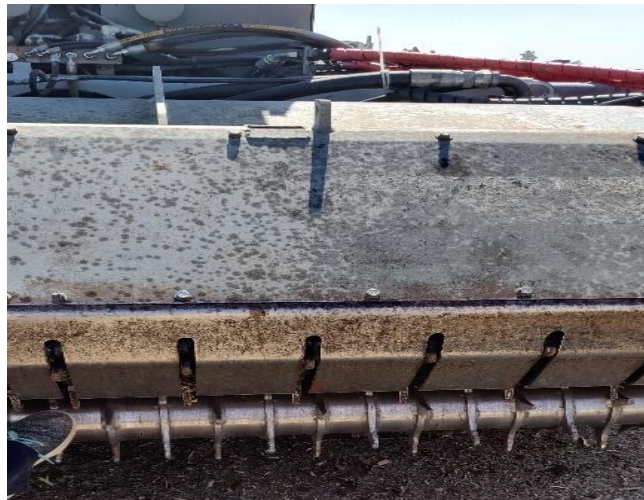
The brush shredder in this incident was hydraulically-powered and had a rotating feed roller equipped with a row of approximately five-inch teeth (Exhibit 1). The forward rotating motion of the teeth grinds and shreds branches. The operator controls the direction of the feed roller with a forward switch and reverse switch. The reverse switch is used to eject jammed branches stuck in the teeth. The feed roller is in a raised position when not in operation and is lowered to

Exhibit 1. Roller and shredder teeth.

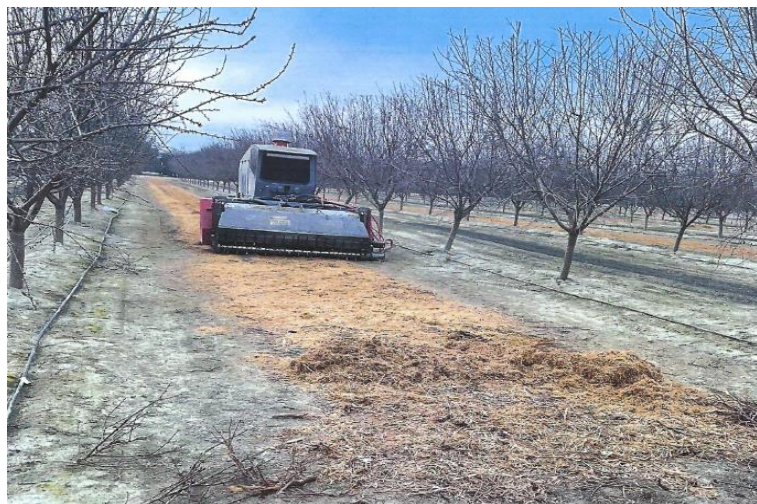
The incident scene is an almond farm in the Central Valley of California. The incident took place in the center of one of the multiple rows of almond trees (Exhibit 2).

Exhibit 2. The brush shredder in the almond field.

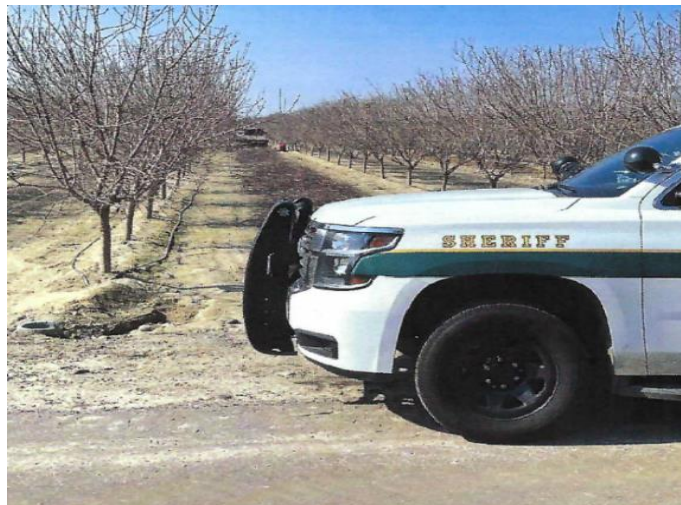
The next morning on Sunday, February 7, 2021, at approximately 9:45 am, the contractor went to the incident site and found the victim in the middle of a row of almond trees caught in the blades of the brush shredder (Exhibit 3). First responders were notified and found the victim deceased upon arrival.

Exhibit 3: The sheriff arriving at the incident scene.

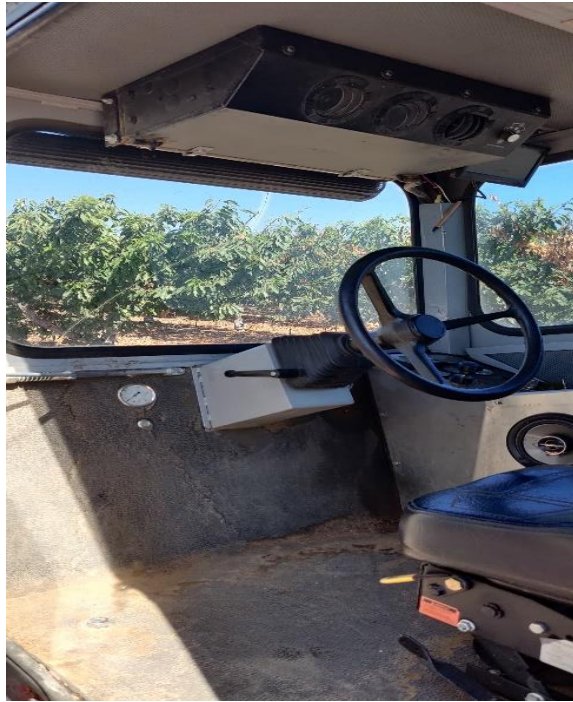
- **Location of Labels:** Labels should be visible from a distance not obstructed by other parts of the machine. Wider machines may benefit from having two labels, one on each side. Labels should be on both the inside of the cab and the outside of the shredder. Exhibit 4 shows that there were no safety warning labels inside the brush shredder involved in the incident.

Exhibit 4. No warning labels were posted on the inside of the cab.

**Recommendation #3: Post clearly visible and language-appropriate safety warning labels both inside the cab and on the outside of the shredder above the feed roller.**

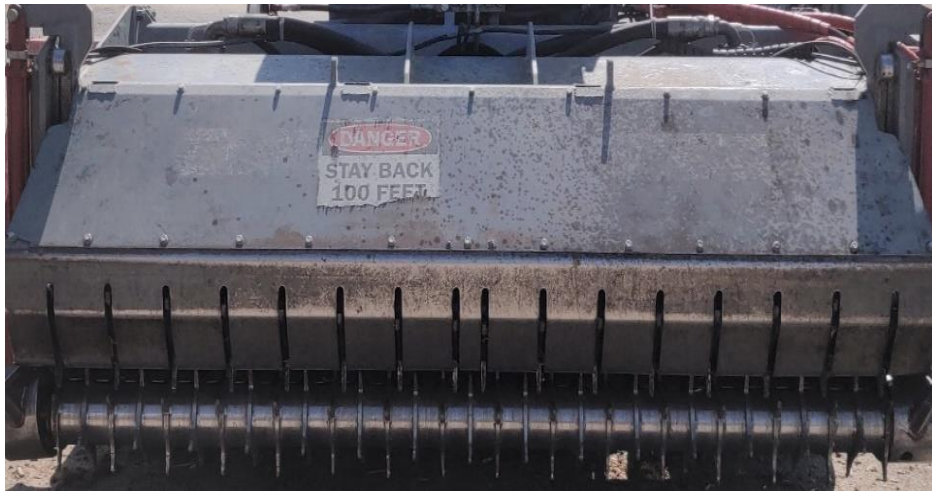
- **Periodic Inspection of Labels:** All labels fade with time. It is important to periodically inspect the labels and replace those that are fading. Exhibit 5 shows the fading label on the outside of the brush shredder involved in this incident.

- **Training:** Employers should train workers on how to recognize and interpret posted safety labels. Languages used on the labels should be understandable to workers. Figure 5 shows that the label on the machine involved in the incident was only in English.

Exhibit 5. Faded warning sticker on the front of the shredder.
